**Swing Flex® Check Valve
Proof of Performance
Test Report**

Val-Matic Swing Flex® Check Valve
Size 6", Model 506 with ANSI 125 LB. Flanges,
Cast Iron Body and Cover, Nylon and Steel
Reinforced Buna-N Disc.

Observation of Performance Tests

PSI No: 150-38027-001

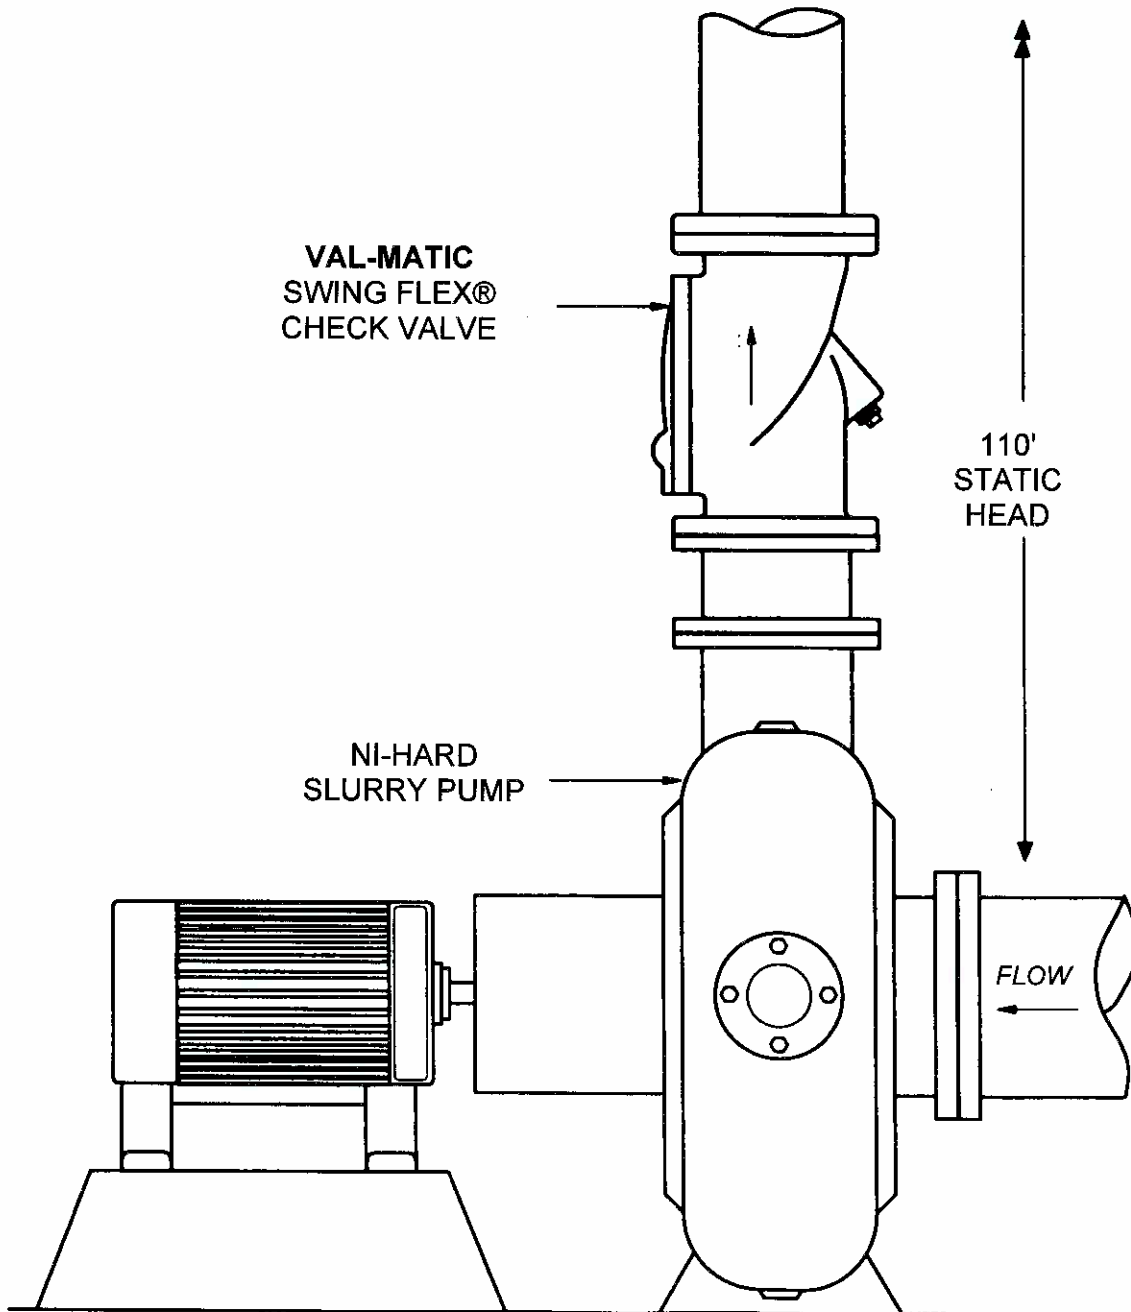
Figure One

The valve was installed in a coal burning, 220 MWT power station, in a bottom ash recovery system. The system has been in service for 15 years. Flow conditions through the valve are as follows: The valve is mounted in a vertical flow up position just off an 800 GPM Ni-Hard horizontal slurry pump (Figure One). Head is 110 feet, temperature varies from 110°-130° Fahrenheit. The media is light bottom ash suspended in recovery water. It is extremely aggressive, as it is not only very abrasive, but also corrosive due to the acidic nature of the water. The system is typically in service 24 hours a day and cycles approximately 30 times a day.

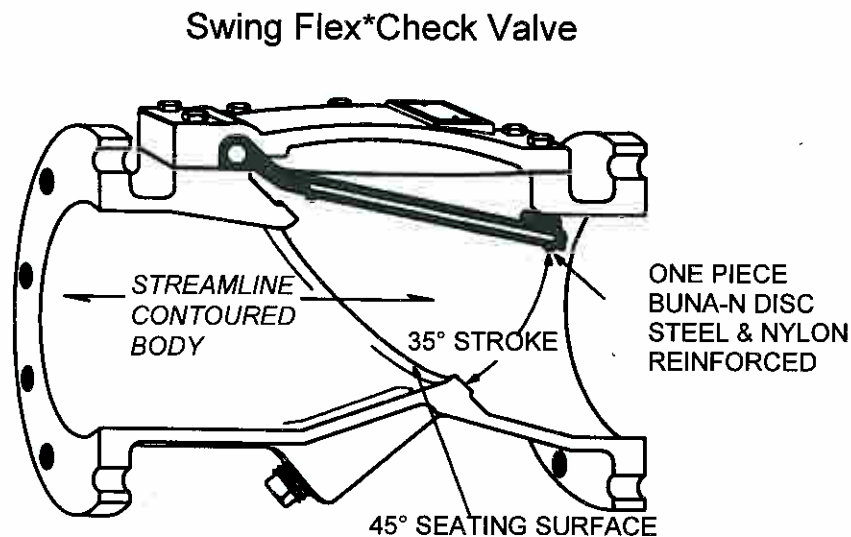
In October of 1987 the user decided to try a Val-Matic Swing Flex type check valve (Figure Two).

The Swing Flex utilizes a one piece steel and nylon reinforced Buna-N rubber disc. The seat is on a 45° angle minimizing disc travel and therefore minimizing slamming. The cast iron body is streamlined and contoured to allow for smooth, non-turbulent flow through the valve.
